Manhole Inspection Summary

Manhole # S33UU_024MH

Insp Date: **4/13/07 10:09 AM**

Location Address: **2802 MACE ST**

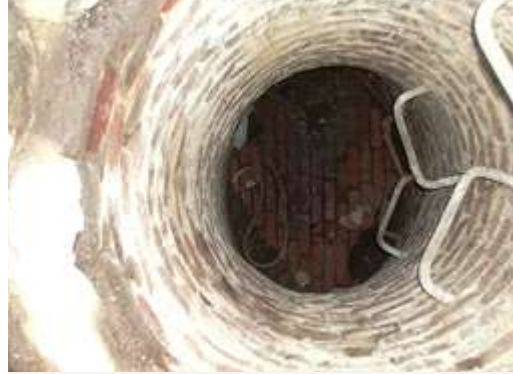
Top View

Corroded steps. Channel debris.

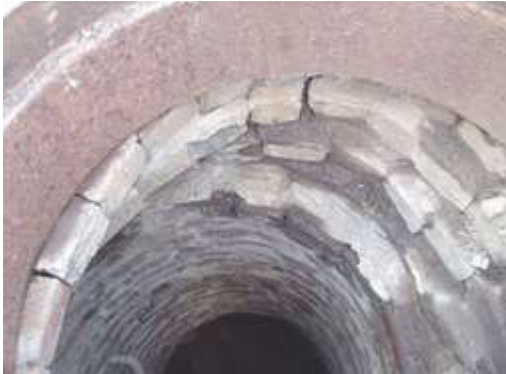
Defect

Frame leaks. Adjustment deterioration, loose brick and infiltration. Corbel infiltration.

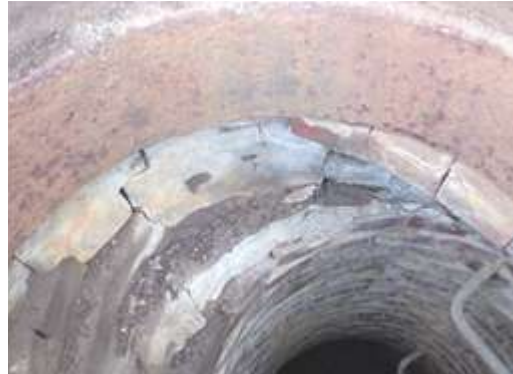
Defect

Frame leaks. Adjustment deterioration and infiltration.

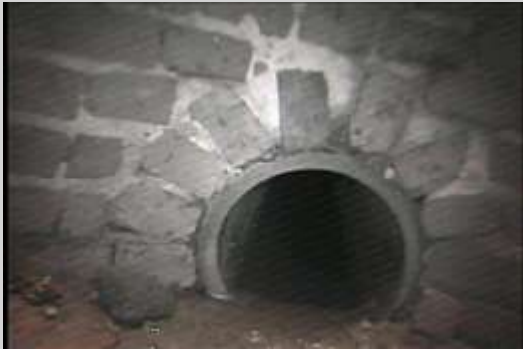
8 in. Circular Gravity Sewer Pipe Out @ 12 O'Clock

Infiltration: **Evidence** Pipe Seal Cond: **Cracked**

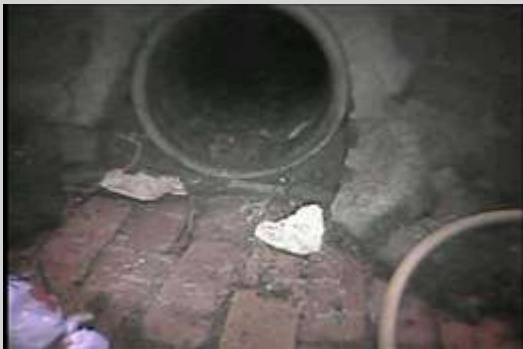
8 in. Circular Gravity Sewer Pipe In @ 6 O'Clock

Deposits: ☐ None ☒ **Mud** ☐ Sludge ☒ **Debris** ☐ Grease

Silt Depth: **0.5** (in.) Deposits Extent: **Light**

Infiltration: **Evidence** Pipe Seal Cond: **Unknown**
